Arboricultural Impact Assessment and Tree Protection Plan

Harvest Lane, Charlton Horethorne

2nd August 2023

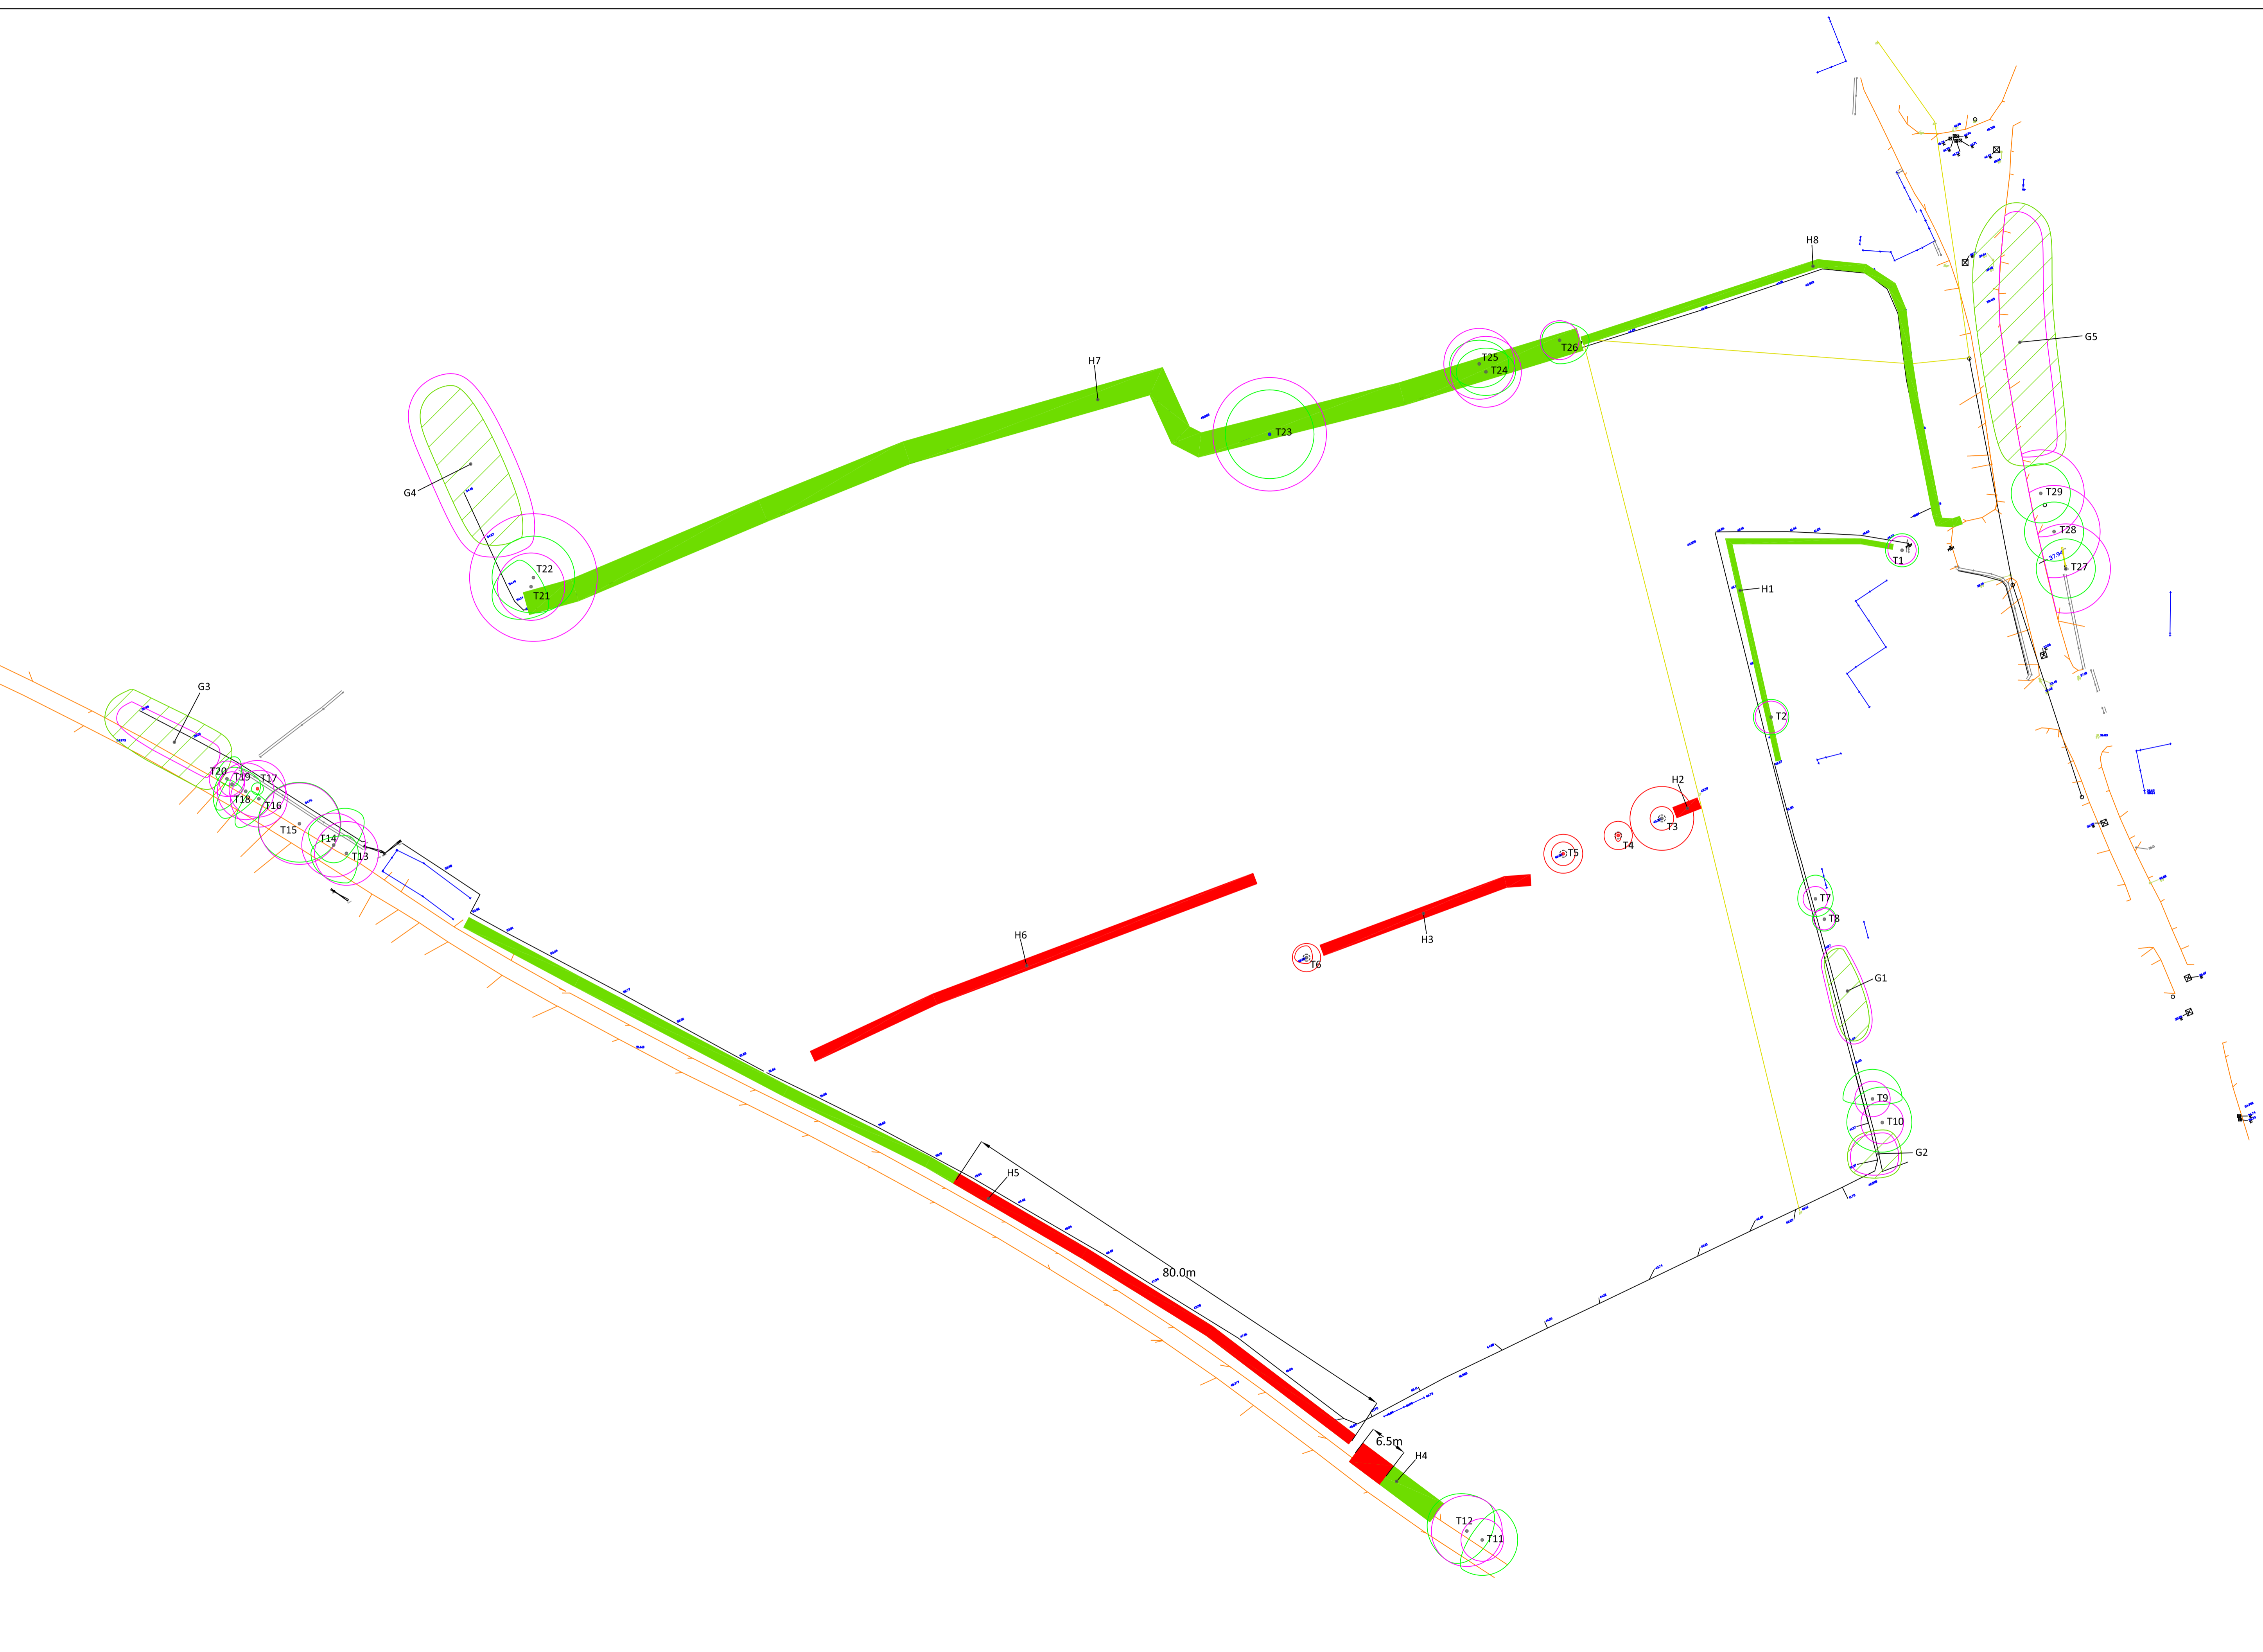
Drawing Number:	Revision
TR-1

3.1.1 Four trees will need to be removed in order to construct the proposed development, these include two C-grade trees (T3 & T6) and two U-grade trees (T4 & T5).

3.1.2 Three hedges will also need to be removed (H2, H3 & H6) and two further hedges will need to be partially removed (H4 & H5). These are all C-grade arboricultural features.
