FLOOD RISK ASSESSMENT AND DRAINAGE STRATEGY

# Hopkins Estates

Land at Harvest Lane, Charlton Horethorne

July 2023

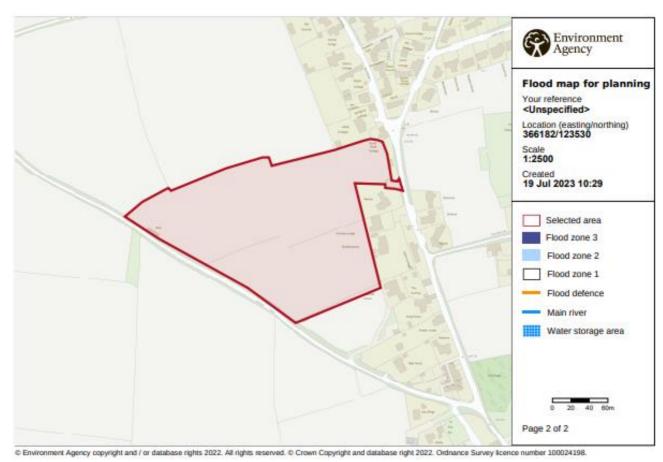
Figure 2: Flood Map for Planning

4.1 The EA Flood Map for Planning (see Figure 2) shows the risk of flooding from rivers and the sea. It locates the entire site in Flood Zone 1. This means it has a low probability of flooding from these sources.
